MPS Playground Safety Inspection Report

School/Building: Cooper

Playground Location: Northeast of School

Date of Inspection: 5/15/2023

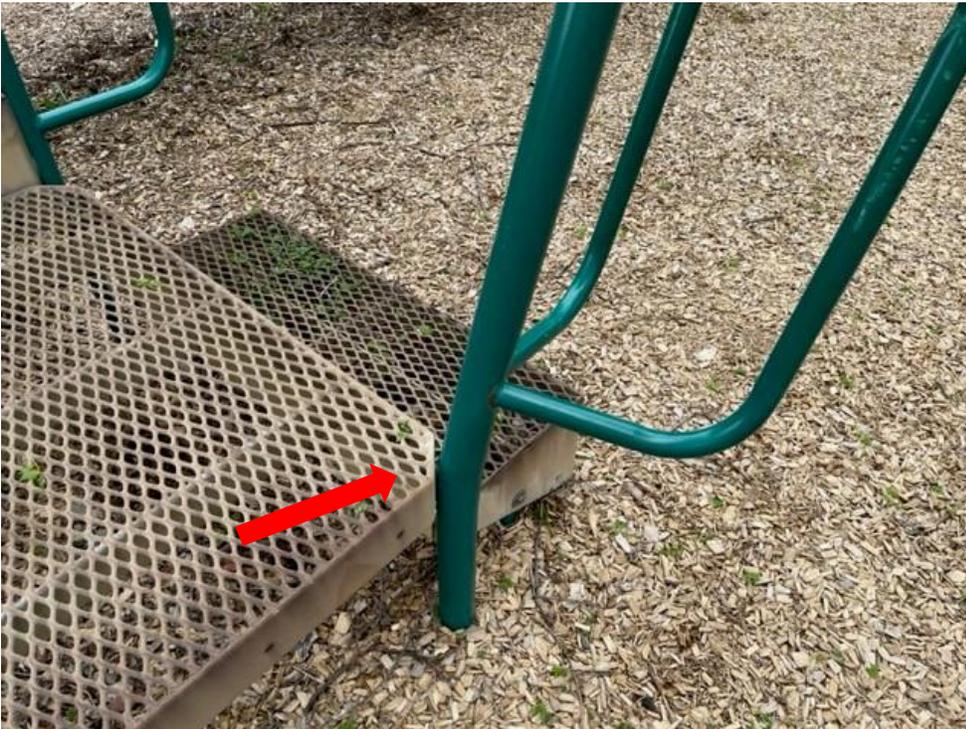
5. <u>Hand rails, Barriers, Pots, Roofs, Shelters</u> (Visible cracks, bending, warping, rusting or breakage of any components)	N	The south handrail on the entry point of the playground is bent and loose and should be replaced. (Priority 3)

5. The metal handrail is bent and loose.

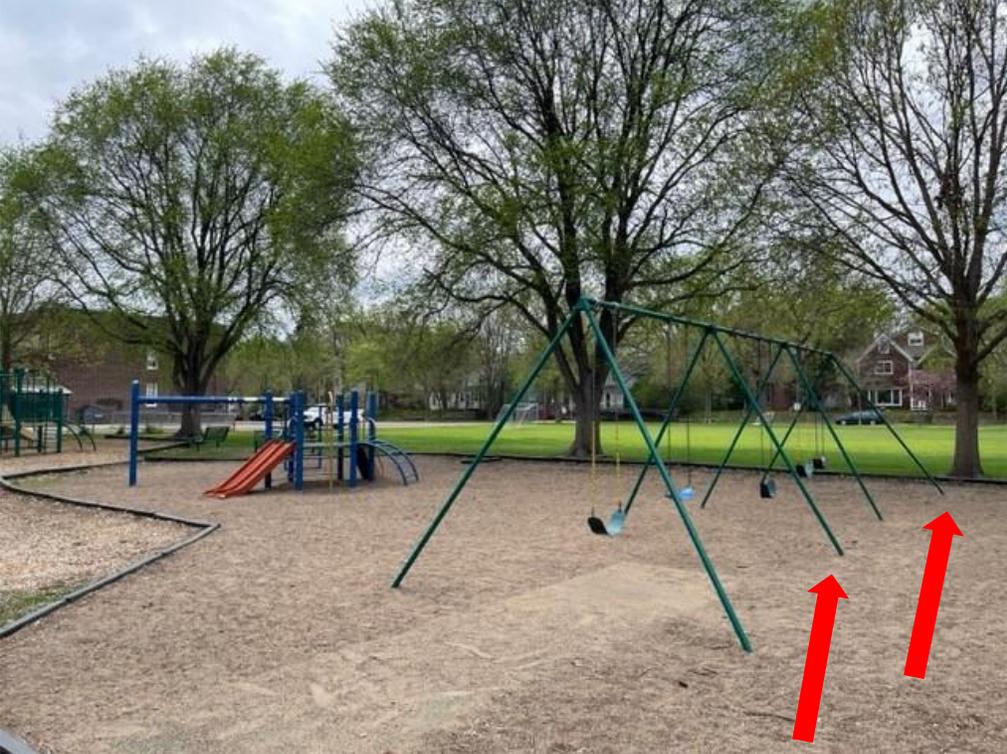
13. <u>Footings</u> (Exposed, cracked or loose in the ground, broken supports/anchors)	N	The concrete footing for the swings are partially exposed. Sand should be moved and cover the footings routinely. (Priority 1)

15. <u>Ground Cover</u> (No trash, broken glass, rocks, feces, weeds, shrubs, sand burrs, thistles, etc.)	Y	
16. <u>Surface Under Swings & Other Equipment</u> (Low, hard or compacted, wash outs, exposed fabric or rubber pads)	N	Sand is used for ground cover material around the swings. In this application, sand does not meet industry standards and should be replaced with EWF. (Priority 1)

13 & 16. The concrete footing become exposed under the swings.

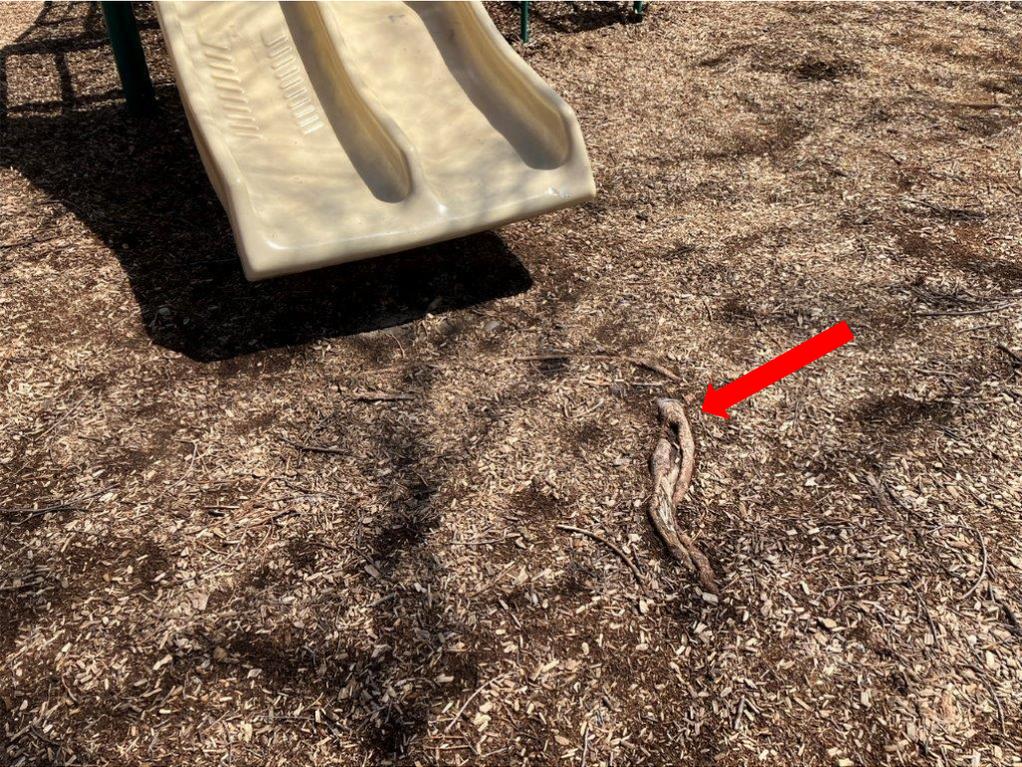
17. <u>Fall Zone</u> (Foreign objects in the 6' diameter under and around equipment)	Y	
18. <u>Tripping Hazards</u> (Roots, rocks or other environmental obstacles)	N	Additional mulch is needed in the south and east portions of the playground to cover the exposed roots that are creating a trip/fall risk. (Priority 2)

18. Exposed roots which create trip hazards.

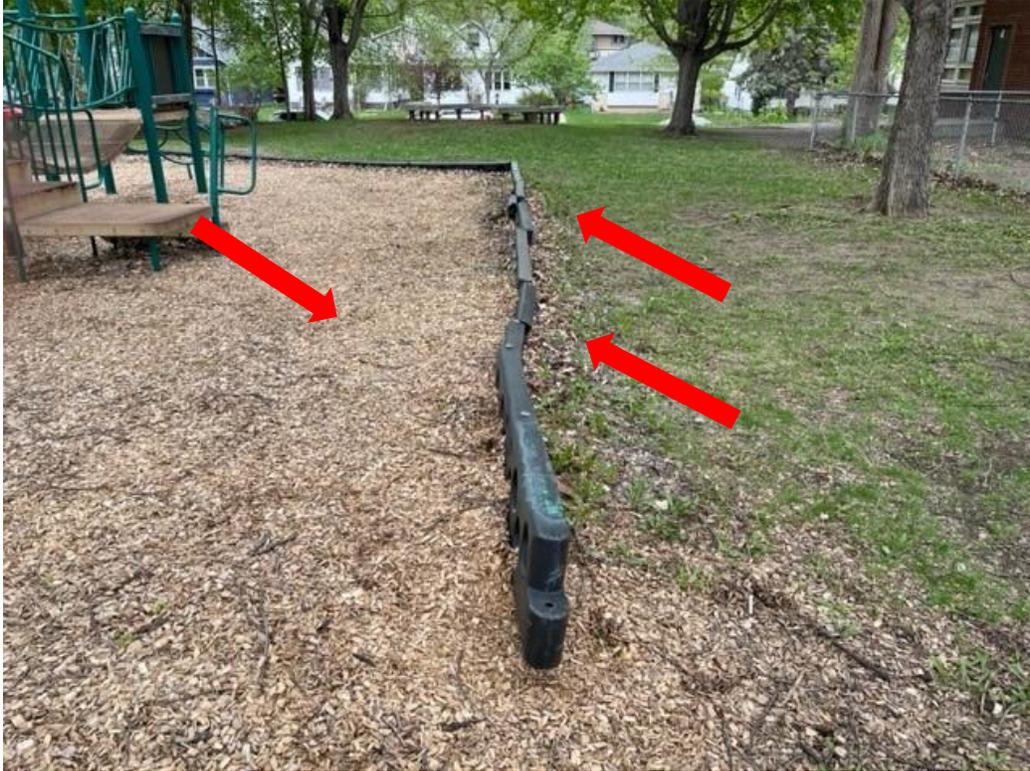
19. <u>Collections of Dirty/Contaminated Water</u> (Poor drainage areas, fungus or mushroom growth, etc.)	Y	
20. <u>Playground Border</u> (Timbers rotting, splitting, uneven or excessive wear. Damaged poly, concrete, block or asphalt. Loose/missing spikes. Fence or gate condition)	N	The plastic border is missing spikes. The border is in poor condition and are in need of repair. (Priority 2)

18& 20. Exposed roots and the plastic border is damaged.

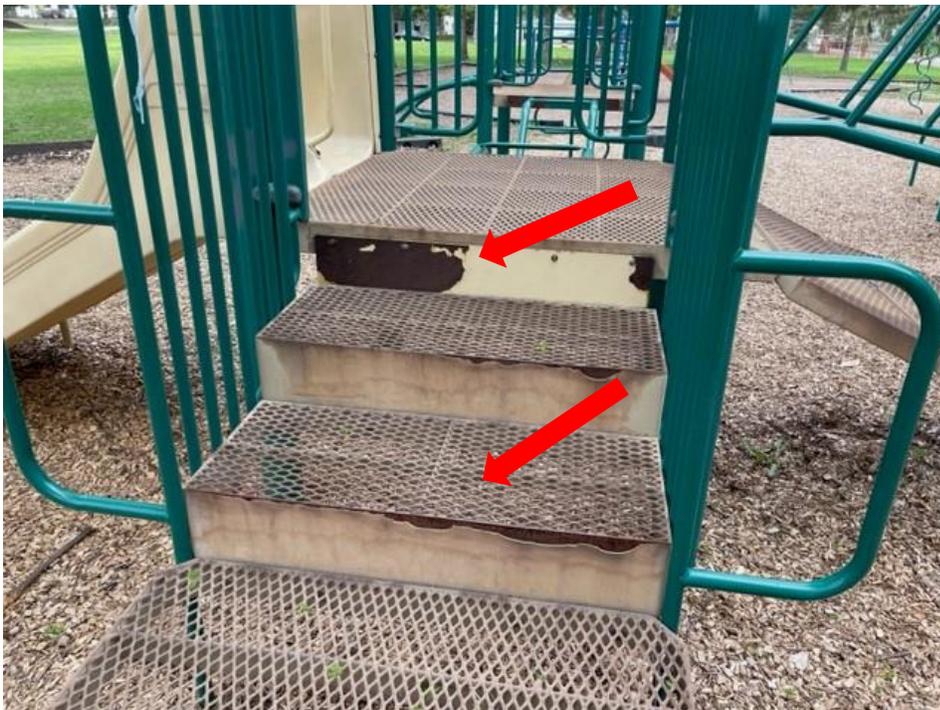
22. Areas of the paint and step/platform coating are deteriorating and so continued monitoring/preventative maintenance is needed. The metal is structurally weak.

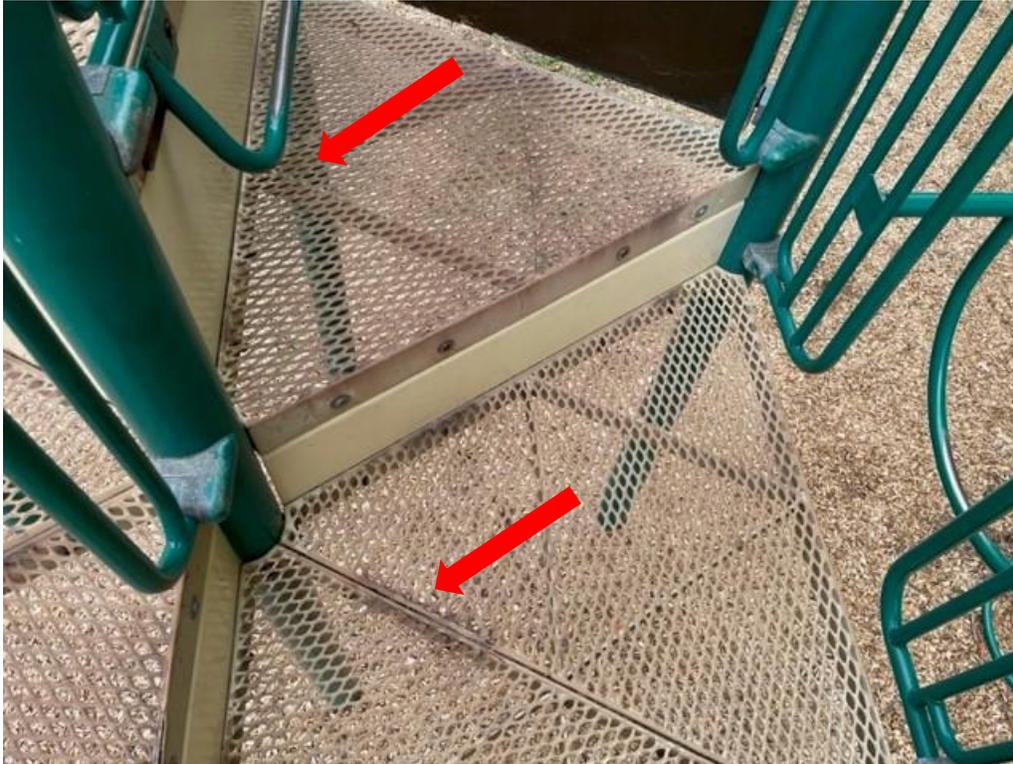
22. The metal of the standing platforms are aging and rusting. Structural integrity of the metal is weakening and is becoming a safety concern.

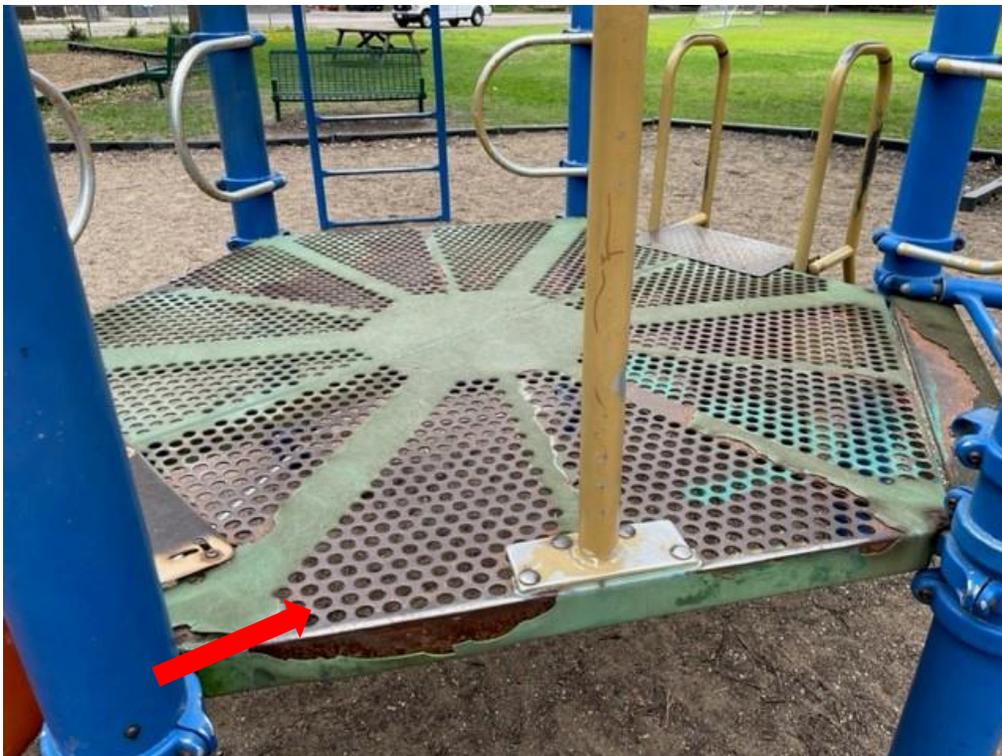
22. The metal of the standing platforms are aging and rusting. Structural integrity of the metal is weakening and is becoming a safety concern.

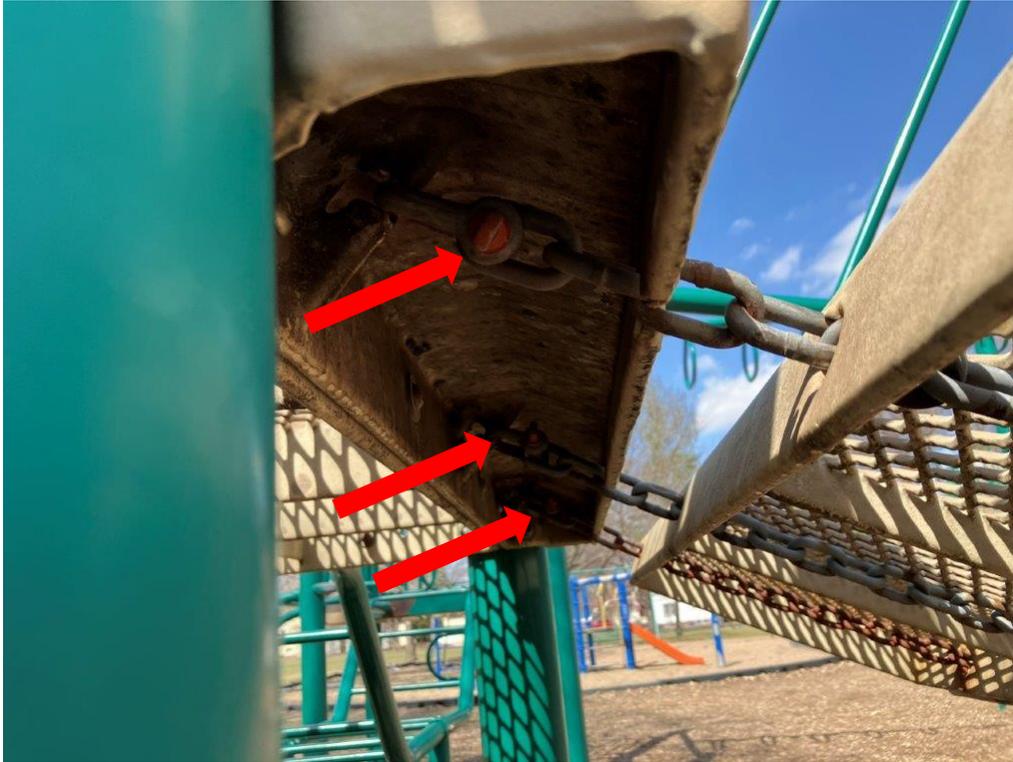
22. The clevises and anchor points for the hanging walkway should be reinforced as they are nearly worn through. This is a structural and safety concern.

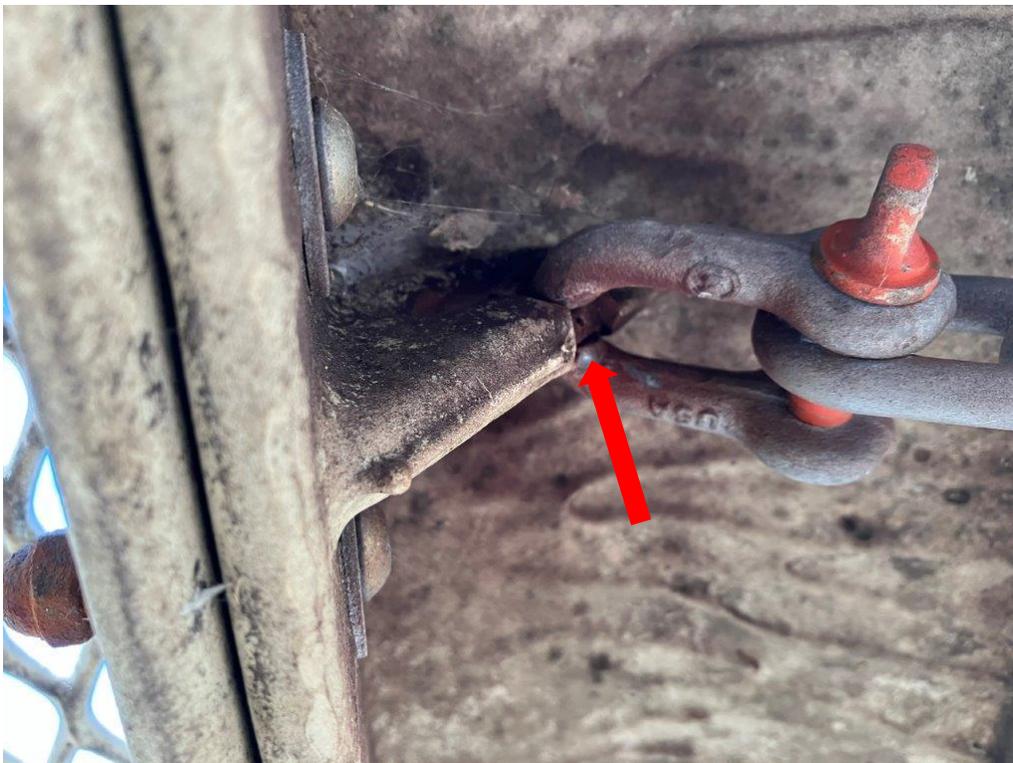
21. <u>Components Needing Lubrication</u> (Chains, axels, hinges, rusted components, etc.)	Y	
22. <u>Misc.</u> (Other loose/missing parts, items of note, etc.)	N	<ul style="list-style-type: none"> • The areas of deteriorating paint and step/platform coating should continue to be monitored due to corrosion of the metal underneath. (Priority 2) • The clevises and anchor points for the hanging walkway are worn thin. The hanging walkway should be removed, and access boarded up (Priority 1)

22. The clevises and anchor points for the hanging walkway should be replaced as they are nearly worn through.
